Manhole Inspection Summary

Manhole # S19KK_041MH

Insp Date: **6/6/07 7:56 AM**

Location Address: **1956 WALBROOK-RIDGEHILL** Cross Street: **PAYSON ST**

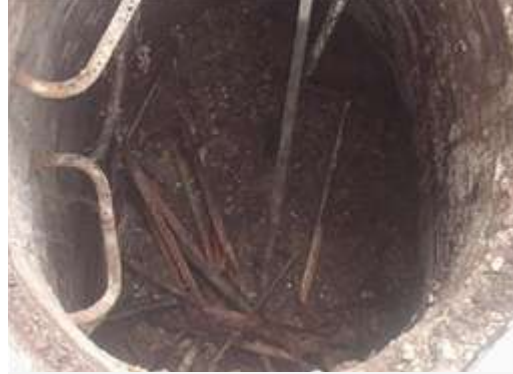
Top View

Comments **USED 16LB SLEDGE AND PICKAXE TO PRY OPEN LID. MANUALLY ENTERED MANHOLE TO CLEAN AWAY DEBRIS FROM O12 CONNECTION. TOOK NEW PHOTO AND ATTACHED IN MIAS. REWORK COMPLETE 3-3-09.**

DEBRIS

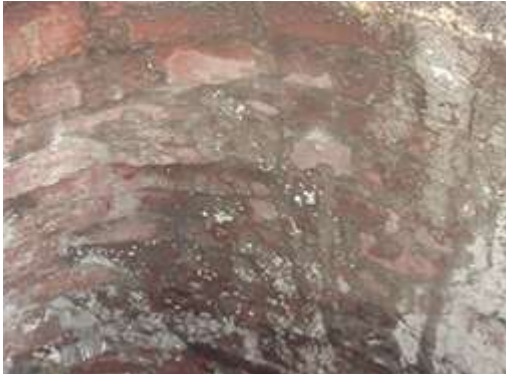
Defect 2

Corbel Material: **Brick** ☐ Parged Type: **Concentric/Eccentric**
Condition: ☒ Sound ☐ Cracked ☐ Root Intrusion ☐ Loose Brick ☐ Deteriorated
Infiltration: ☐ None ☐ Joint ☐ Cracks ☐ Mortar ☐ Roots ☒ **Wall**

INFILTRATION OF CORBEL WALL

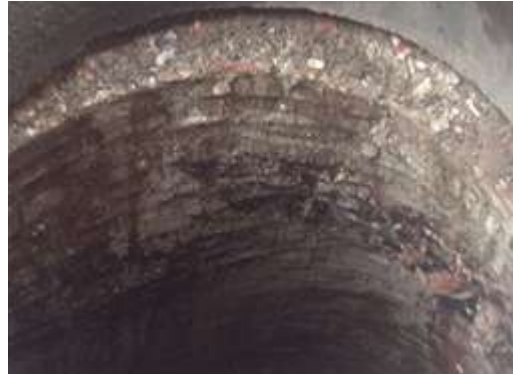
Defect 1

Frame Offset: **2** (in.) Condition: ☒ Sound ☐ Cracked ☐ Leaks

FRAME OFFSET

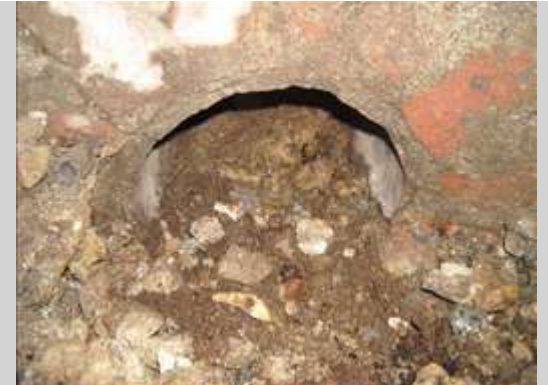
12 O'Clock Outflow

8 in. Circular Gravity Sewer
Pipe Out @ 12 O'Clock

Deposits: ☐ None ☐ Mud ☐ Sludge ☒ **Debris** ☐ Grease

Silt Depth: **3** (in.) Deposits Extent: **Medium**
